FIRE SAFETY FOLLOW UP INSPECTION

Factory Name	KM Nobely Garments Ltd		Factory ID	23244
Address	Zorun, Konabari Gazipur-1702			
Initial Inspection Date	21-Dec-2020		Report Received Date	
Date of 1st Follow-up	16-May-2022	Date of 2nd Follow-up	10-Sep-2023	
Date of 3rd Follow-up		Date of 4th Follow-up		
Date of 5th Follow-up		Date of 6th Follow-up		
Date of 7th Follow-up		Date of 8th Follow-up		
Date of 9th Follow-up		Date of 10th Follow-up		
Date of 11th Follow-up		Date of 12th Follow-up		
Date of 13th Follow-up		Date of 14th Follow-up		
Date of 15th Follow-up		Date of 16th Follow-up		
Date of 17th Follow-up		Date of 18th Follow-up		
Date of 19th Follow-up		Date of 20th Follow-up		
Inspected by	Monsurul Akram Azim & Ahammad Kabir

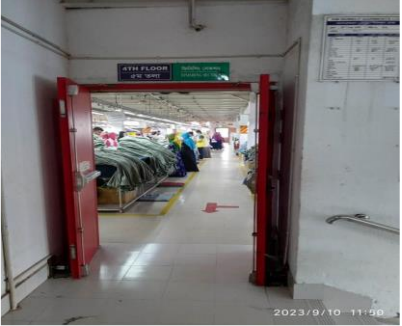
Item No	Inspection Observation	Inspection Recommendation	Timeline given	Comments after Physical Inspection	Supposed to complete(DD /MM/YYYY)	Final Action Plan (Factory)	Status on the date of Inspection	Pictorial Evidence
1	Building-1&2: The exit stairs are not separated from work areas and other spaces on each floor by fire-rated construction.	Provide a minimum 2-hr fire rated shaft to separate the utility risers from each floor level and seal all penetrations in floor/ceiling assemblies to maintain the fire separation. Provide minimum 1.5-hr fire rated doors for buildings that are 4 or more stories. Seal all unprotected openings to separate the exit stairs from work areas and other building spaces on all floor levels. Seal all penetrations and openings in exit stair enclosure walls to maintain the fire separation as per Accord standard 6.3.1.3. Ensure that the fire doors are self-closing and positive latching and that they are provided with fire exit (panic) hardware where serving production floors. If fire doors are required to be held open for functional reasons, provide automatic closing devices tied to the fire alarm system. Once fire doors are installed, every door in a stair enclosure serving more than 5 stories shall be provided with re-entry unless it meets ACCORD standard 6.8.3.1.	Within 3 months	On 16/May/2022: Doors were found open without interfacing with FACP. Fire door and accessories certificate shall be provided and checked for all model and manufacturer. 2-hr fire rated construction (10 inch brick wall and protected steel member) shall be completed. Utility pipe and all other penetration shall be removed from exit stair enclosure as per RSC 6.14.4. Exterior stairs of building-1 and building-2 shall be separated from building interior as well as adjacent new building as per RSC 6.3.1.3. On 10/09/2023: Corrected. Factory has been provided fire rated door in the exit to separate the staircase from work areas.	18-Apr-2021	Fire door installation work has completed. The utility pipe has been removed from the stairs. On the other hand, all penetration has been removed from exit stair enclosure. It has been done	Corrected

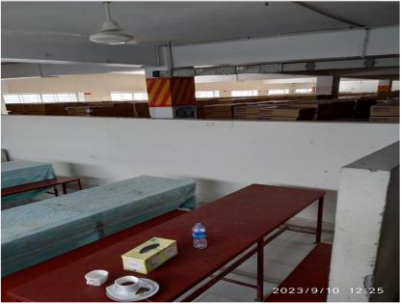
2	Building-1&2: Storage rooms and process areas used for combustible storage are not separated by fire rated construction on 1st & ground floor in building-1 and ground & 1st floor in building-2 respectively.	Rooms used for storage of combustible materials shall be separated from the surrounding occupancy with a minimum 1 hour construction. Where separate storage rooms are not feasible, provide defined storage areas and limit the storage arrangement as follows: 1. General Condition: Maximum height of 2.4m and maximum area of 23m2. Separate areas of unenclosed combustible storage by a minimum clear distance of 3m. 2. If sprinkler protected; maximum height of 3.66m and maximum area of 93m2. Separate areas of unenclosed combustible storage by a minimum clear distance of 3m.	Within 3 months	On 16/May/2022: In process storage limitation is not maintaining in 1st and 2nd floor. If factory defined the 1st floor storage as dedicated storage then completed fire separation and exit vestibule shall be provided as per RSC 6.14.3. On 10/09/2023: factory has been provided fire door in the storage area. Canteen is found in the storage area which need to relocate from the storage area.	18-Apr-2021	Fire separation work is complete on between the office and the store room. Excess goods placed on the floor now has been removed from the floor. It has been done.	In Progress

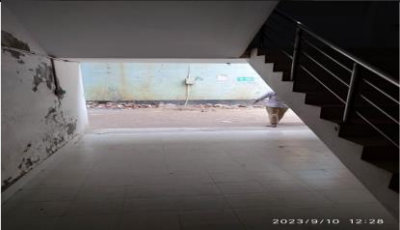
Item No	Inspection Observation	Inspection Recommendation	Timeline given	Comments after Physical Inspection	Supposed to complete(DD /MM/YYYY)	Final Action Plan (Factory)	Status on the date of Inspection	Pictorial Evidence
19	New Finding: Storage was located in the exit stair at building-2 shared stair with new building.	Remove all storage from exit stairs. Keep egress paths and stairs clear of storage.	Immediately	On 16/May/2022: New Finding On 10/09/2023: Corrected.	19-May-2022	Remove all storage from exit stairs. Also keep exits and stairs away from storage. It has been corrected.	Corrected

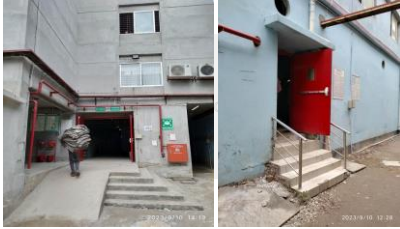
20	New Finding: Compliant stair and landing is not provided from ground floor N-E exit.	Provide compliant stair (tread and riser) with handrail covering full exit and landing as per RSC 6.8.5.	Within 1 month	On 16/May/2022: New Finding On 10/09/2023: In progress. Factory has been working on it. Still some work is pending.	16-Jun-2022	We have provided compliant stair with handrail covering full exit and landing. It has been done.	In Progress
