Testing and Commissioning Verification Inspection Report

FACTORY : KM NOBELY GARMENTS LTD (EXTENSION
BUILDING)

DATE: 16/10/2024

FACTORY ID : 24389

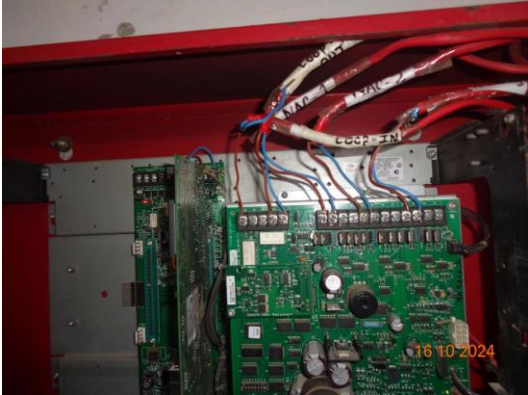
Item	System	Priority	Description
1	FA	Major	<p>During a trouble test at the fire alarm control panel, it was observed that loop-1 is not properly supervised. Open fault was not monitored during the test.</p> <p>For circuits directly connected to the fire alarm control panel, wiring trouble signals (i.e., OPEN CIRCUIT, GROUND FAULT, SHORT CIRCUIT) for the Class A signaling line circuit(s) (SLC) and Class B notification appliance circuit(s) (NAC) are required to indicate trouble signals specific to the trouble condition. Obtaining a single open circuit or ground fault signal shall result in the fire alarm control panel receiving a signal within 200 seconds.</p>

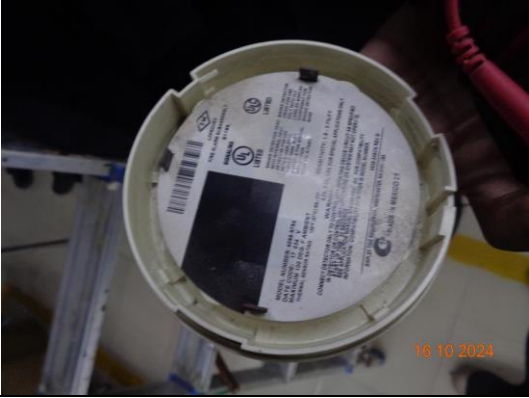
2	FA	Major	<p>The factory has installed fault isolators, but on the 3rd floor of the building, the fault isolator between smoke detector L:2, D:80 and smoke detector L:2, D:79 did not function.</p> <p>Check the wiring and ensure it follows the manufacturer’s published instructions as well as NFPA 72 standards. Also, verify that the fault isolators are functioning properly.</p>

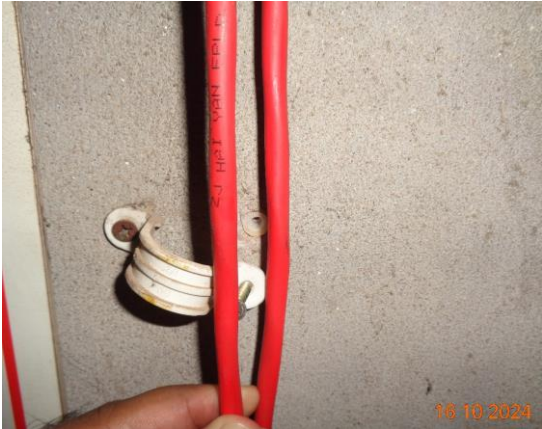
3	FA	Major	<p>Only one cable sample of the TIANJIE brand was provided. However, during a random check, a different cable brand was found installed in the system.</p> <p>Provide samples of each cable type for verification. If the cable type is not listed by an acceptable 3rd party certification company, provide a fire resistance test report conducted by an acceptable 3rd party laboratory. Update all supporting documentation and drawing. If a single known cable type is used for any notification appliance circuit (NAC), apply the cable resistance on the voltage drop calculation as indicated on the manufacturer’s product datasheet. Alternatively, if multiple cable types are used on a single NAC, apply the highest cable resistance value for the circuit on the voltage drop calculation.</p>

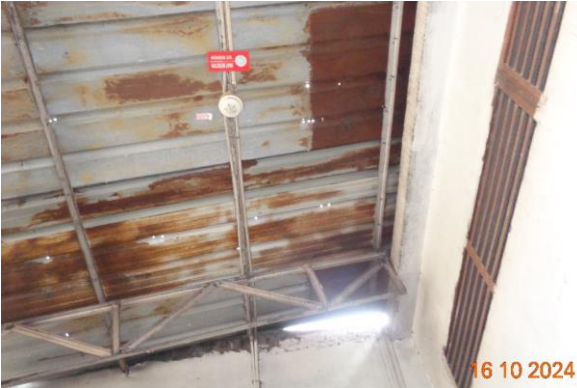
4	FA	Minor	<p>Some device address labels were missing / not fully indicated on addressable devices. (i.e. Generator and ETP room)</p> <p>Verify and provide complete device address labels on all addressable devices. Ensure that device addresses are common between the address indicated on the device, the address indicated on the as-built drawings / riser diagram and the addressed programmed into the fire alarm control equipment. To ensure legibility of all labeled device addresses, the use of a label printing machine is recommended.</p>

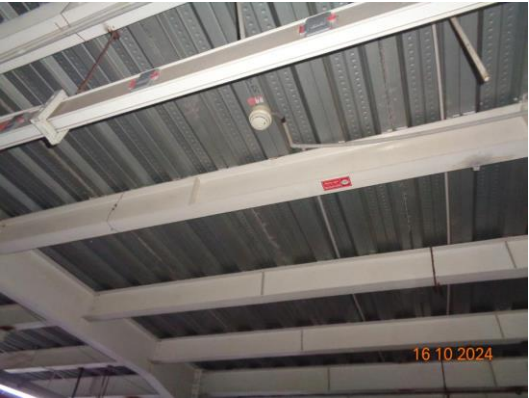
5	FA	Minor	<p>Detection devices and conduits in several areas were not properly mounted to the ceiling, such as on the ground floor of Building-1, the 1st floor of Building-2, and the 1st floor of the Production Building.</p> <p>To ensure proper installation of fire detection devices, all devices and conduits should be securely fastened to the structure with permanent fasteners and back boxes, as required by the manufacturer's instructions. Zip Ties are not allowed for securing to the ceiling.</p>

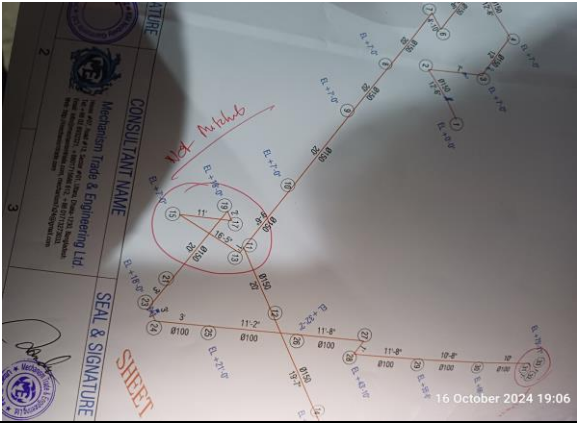
10	SP	Major	<p>Node layout that corresponds with the hydraulic calculation does not match with actual site conditions at a few locations. Redo the hydraulic calculation and provide with the following:</p> <p>(i) Legible node layout that accurately corresponds with the hydraulic calculation.</p> <p>(ii) Supply and demand curve.</p> <p>The maximum system demand is 774.03 GPM and 7.939 bar (115.12 PSI) according to the hydraulic calculation, whereas the pressure at 750 GPM for the diesel pump was observed to be 114 PSI. The factory must ensure that the fire pumps are adequate for the system demand. The factory may increase the pipes size to adjust the system demand.</p>

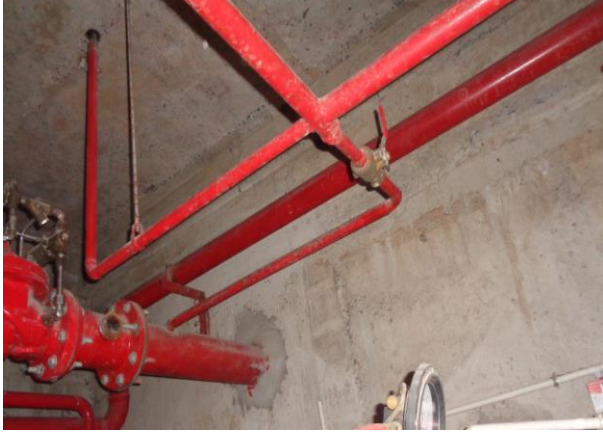
11	SP	Major	<p>Relief valve discharged piping returning water back to the supply source but did not run independently (combined with sprinkler flush line).</p> <p>Relief valve discharge piping returning water back to the supply source, such as an aboveground storage tank, shall be run independently and not be combined with the discharge from other relief valves.</p>
