KM Nobely Garments Ltd.

21st December 2020

Structural Inspection Report

Observations & Actions

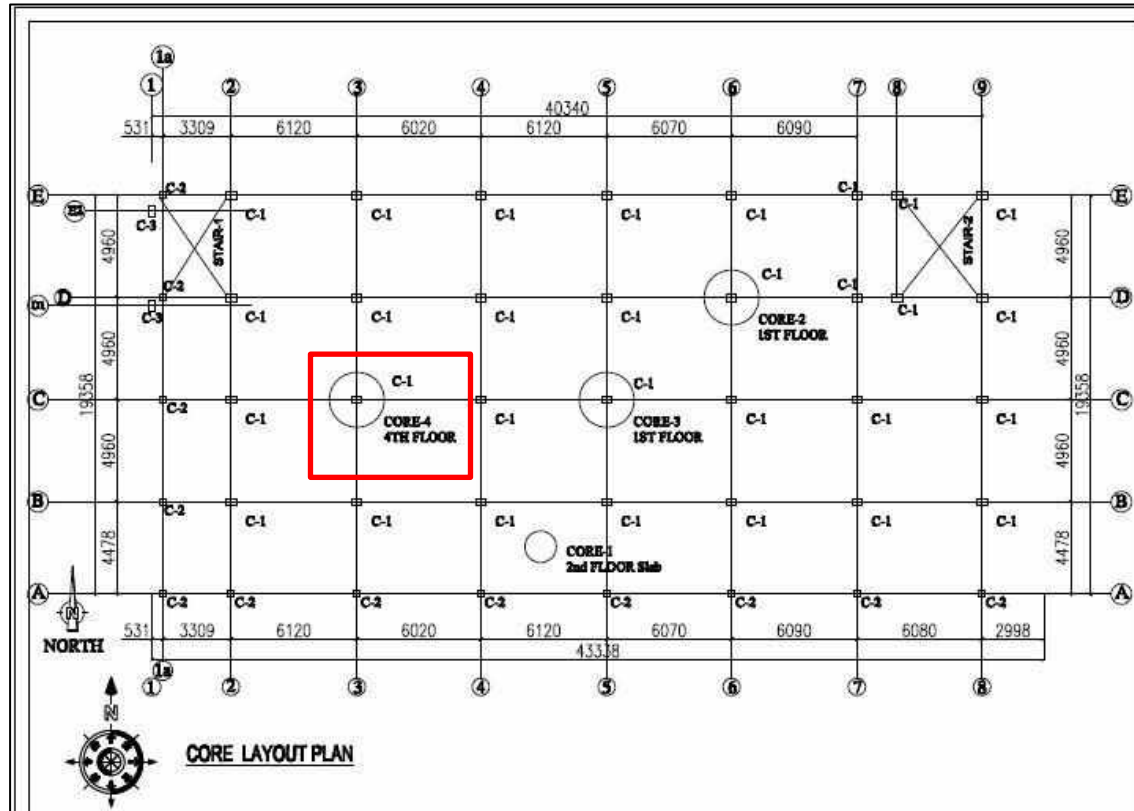
Core layout plan

Total four number of concrete core samples are taken, three samples taken from column & one sample taken from slab. As per core layout plan one core sample was taken from the 4th floor column which is actually constructed for encasing the steel column for fire protection. Factory engineer is required to take minimum number of core samples from columns to evaluate concrete strength.

- Building Engineer to prepare design report as per BNBC (part-6; Article 1.9.1) by reviewing design, loads and capacity of structural members.
- Verify in situ concrete strength by taken 100 mm diameter cores (minimum 4 nos.) from lower tier columns.
- Building engineer is required to check the connection type & requirement of any additional features.

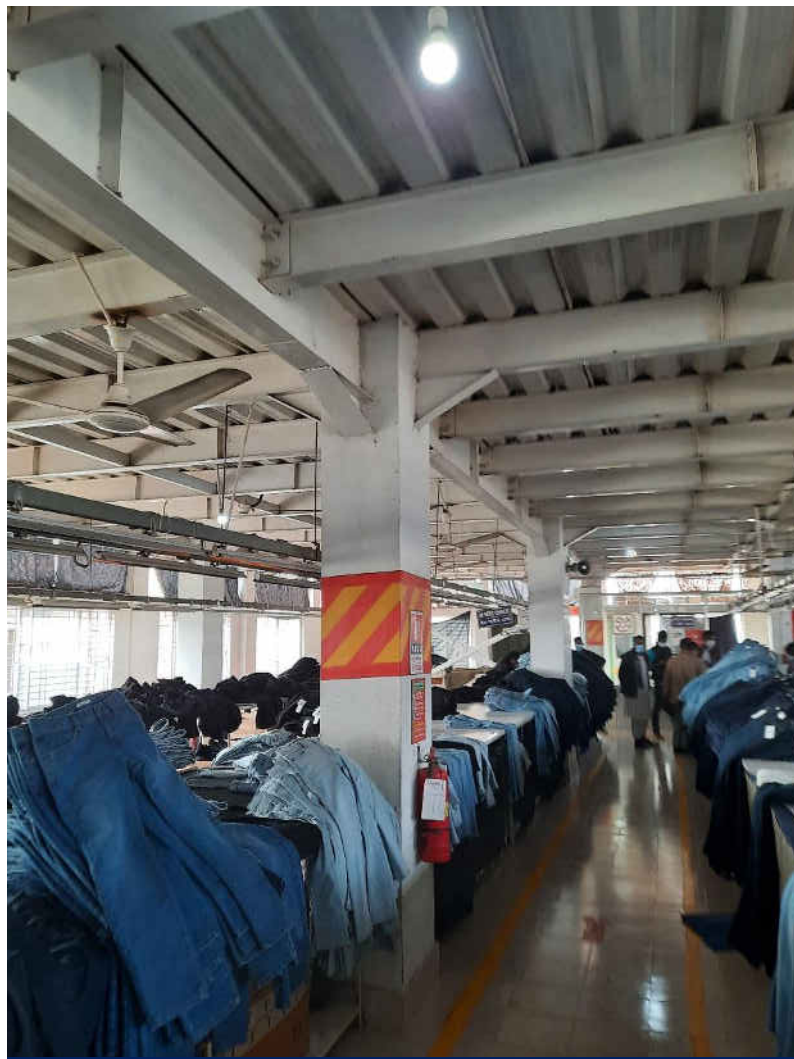
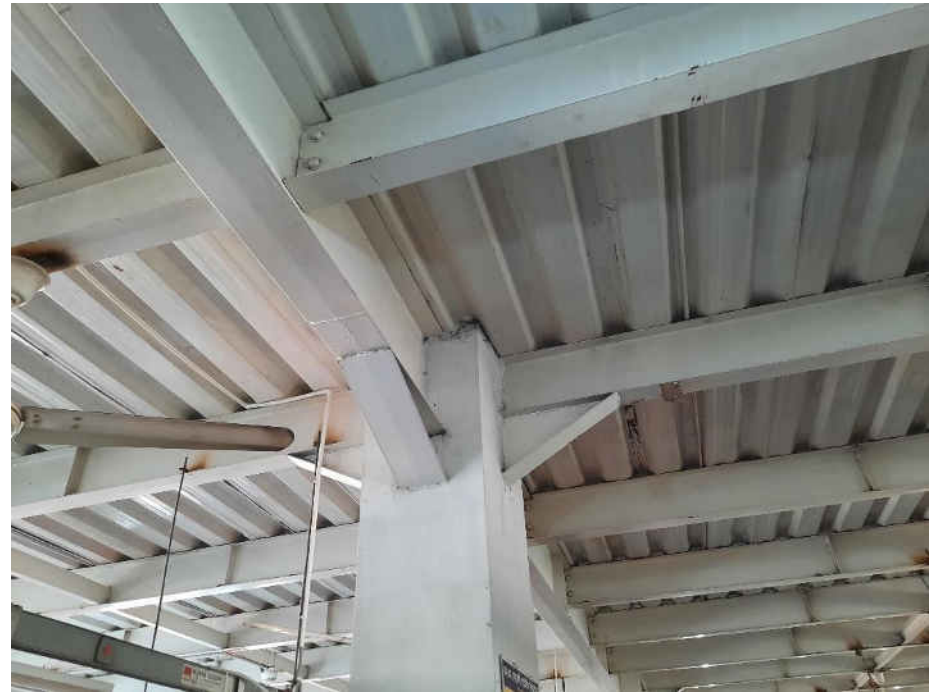
Overall stability of 3rd & 4th floor achieved by the frame action (Main beam in long direction, Sub-beam in short direction) & vertical bracings.

The connection of the frame could not be confirmed due to the RC encasement. Building engineer is required to check the connection type & requirement of any additional features. Serviceability and stability check in the design report is required to comply with BNBC.

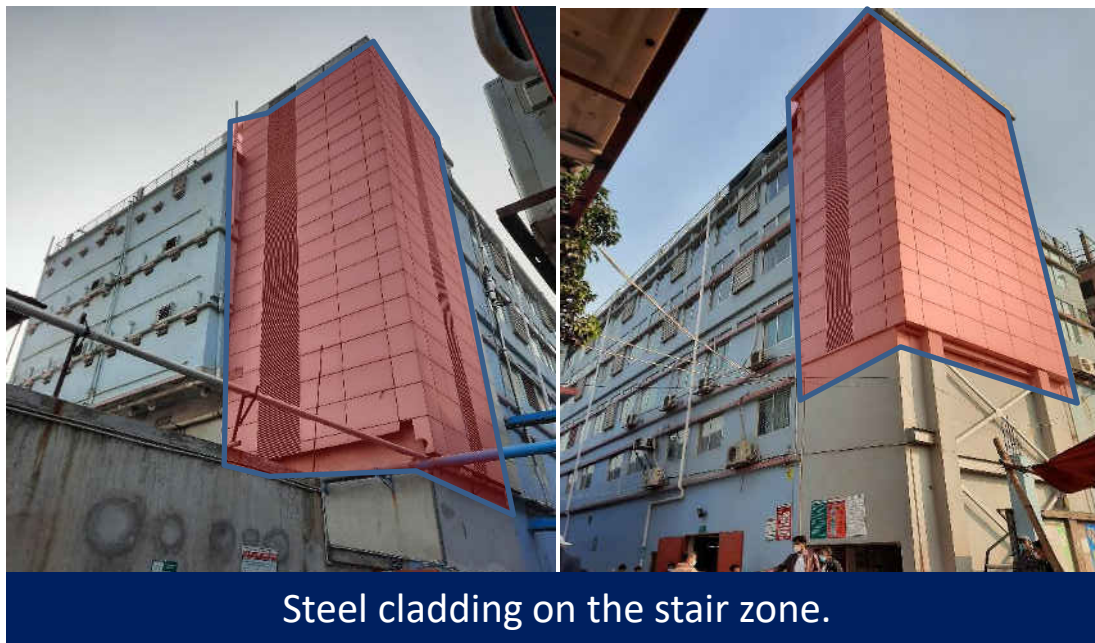
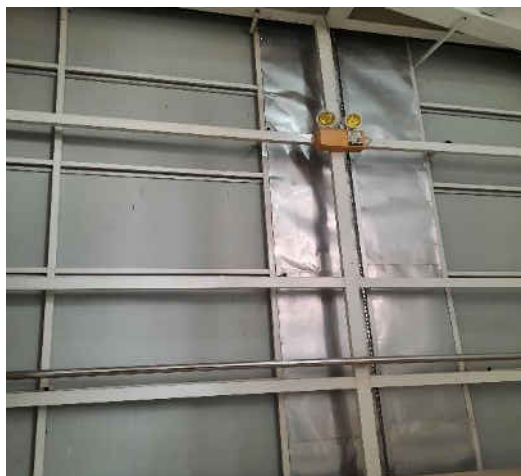
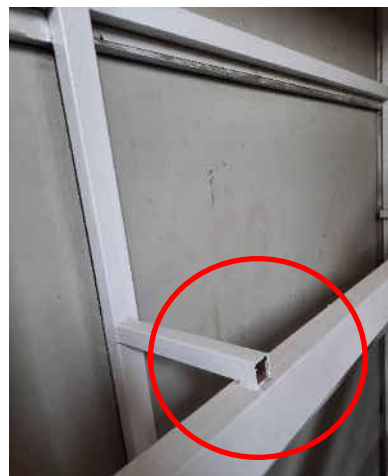
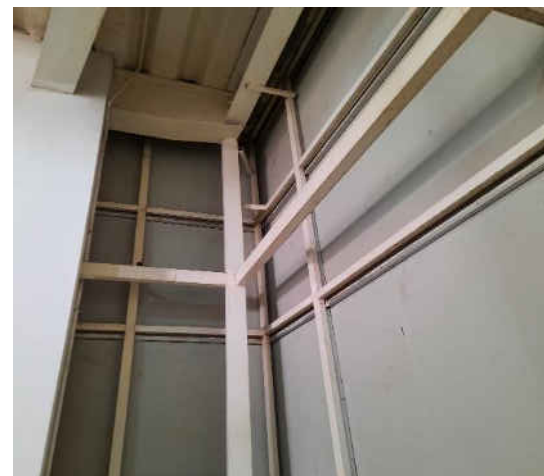
Apparently poor connection in the steel cladding system. Building engineer is required to check the connection adequacy against the wind loading.

- Building engineer is required to check the connection adequacy against the wind loading.

- Complete implementation of any remedial works where necessary.

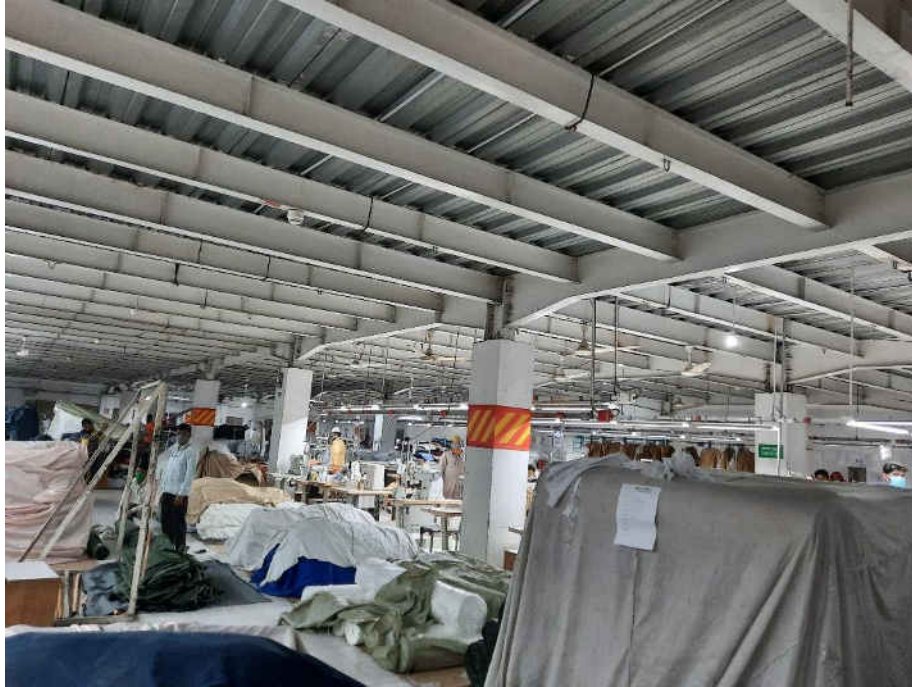
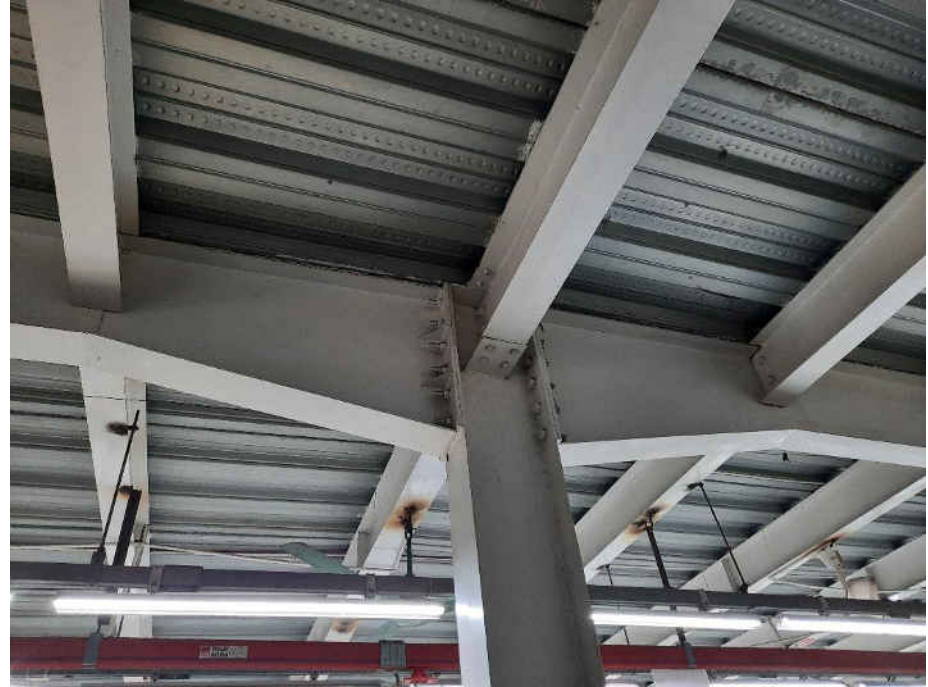
Partially fixed connection was observed at beams and column joint connected by bolts. Apparently partial moment resisting frame action may govern that can affect the stability. Building engineer is required to review the connection adequacy and overall stability system in the design report.

- Building engineer is required to review the connection adequacy and overall stability system in the design report.
- Building Engineer to prepare design report as per BNBC (part-6; Article 1.9.1) by reviewing design, loads and capacity of structural members.

- Carryout remedial works where necessary.

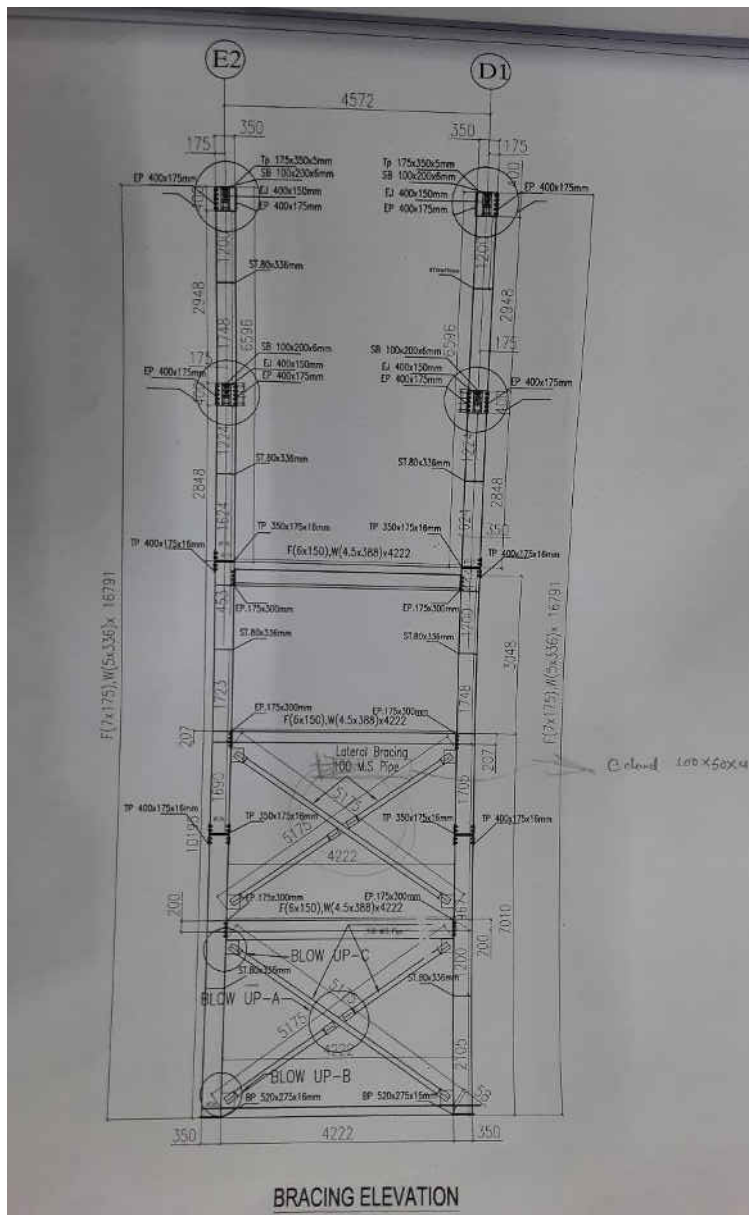
Bracing elevation on drawing

100 mm diameter pipe bracing shown on drawing, onsite C channel of 100 mm X 50 mm X 4 mm bracing was found.

- Building engineer is required to survey the both structures and prepared as constructed drawings.

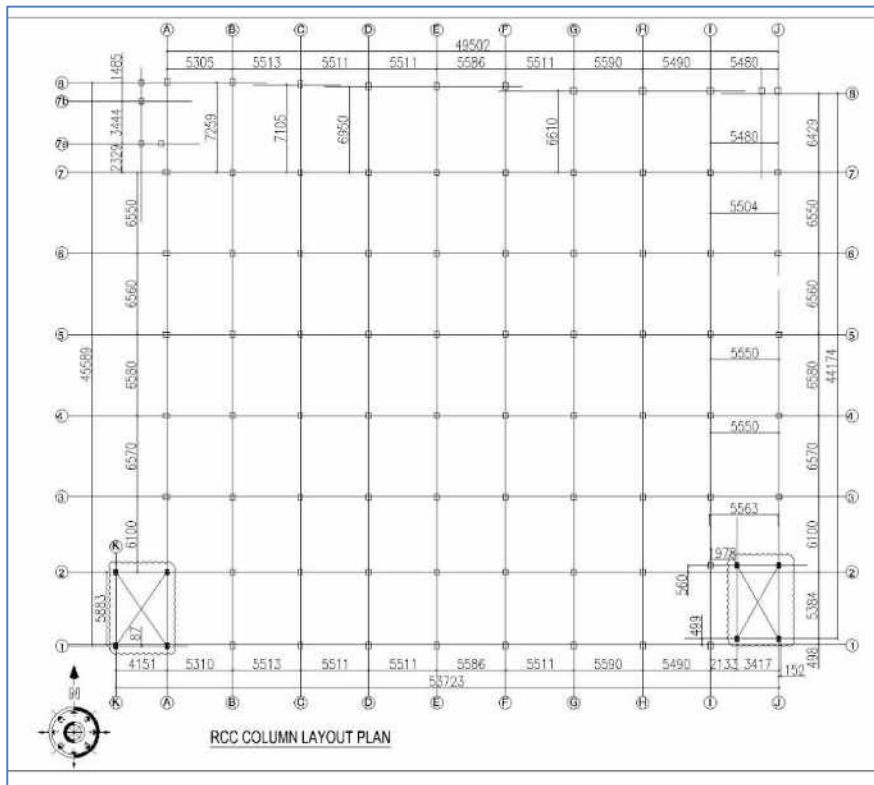
RC column layout plan

As-built drawing shows 12 number of rebars in the C5 column. But on site 8 number of rebars were counted by ferro scanning.
