KM Nobely Garments Ltd.

21st December 2020

Structural Inspection Report

Observations & Actions

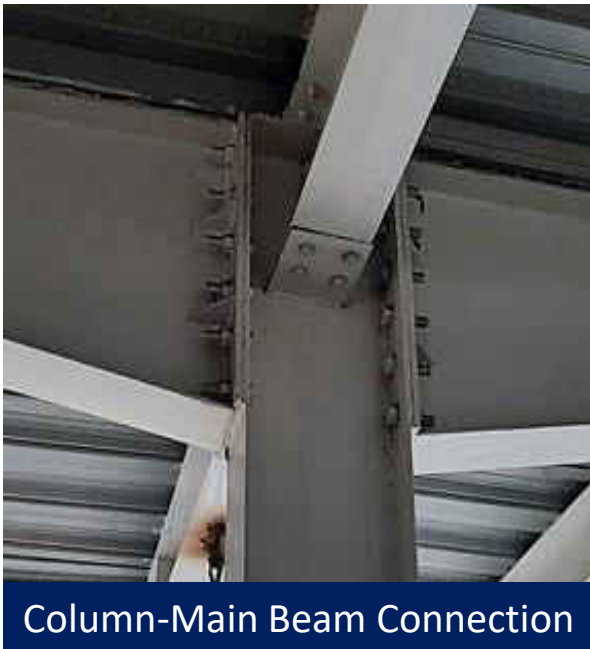
Column-Main Beam Connection

Partially fixed connection was observed at beams and column joint connected by bolts. Apparently partial moment resisting frame action may govern that can affect the stability. Building engineer is required to review the connection adequacy and overall stability system in the design report.
