KM Nobely Garments Ltd.

21st December 2020

Structural Inspection Report

Observations & Actions

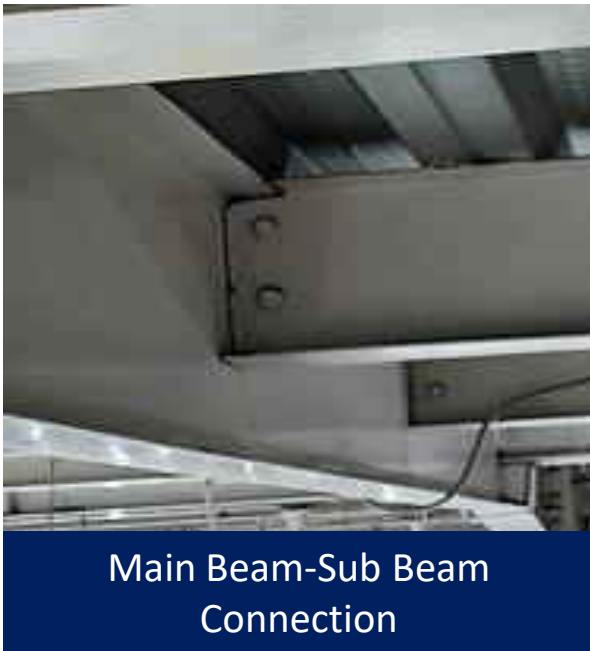
Main Beam-Sub Beam
Connection

Partially fixed connection was observed at beams and column joint connected by bolts. Apparently partial moment resisting frame action may govern that can affect the stability. Building engineer is required to review the connection adequacy and overall stability system in the design report.

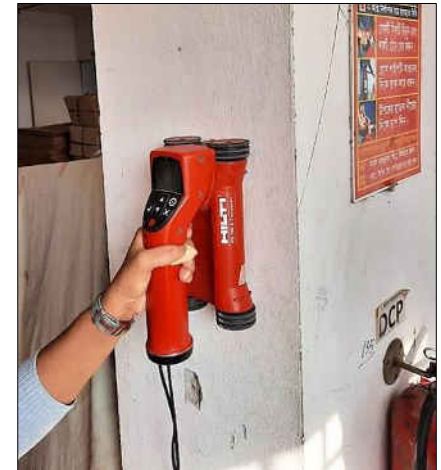
A bit of marked column was broken to determine aggregate type

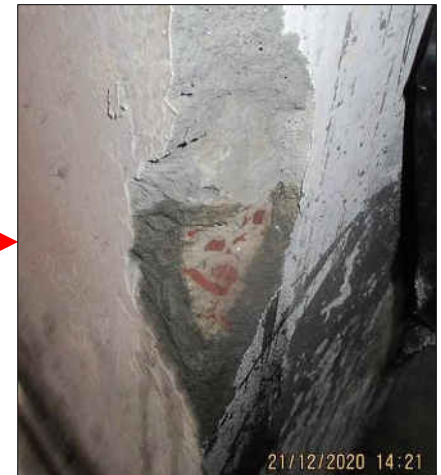
Rebar Scans

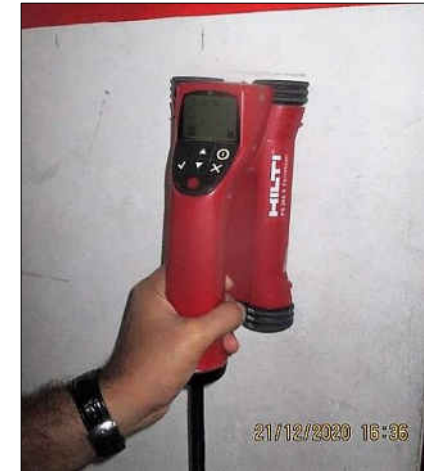
Brick aggregate

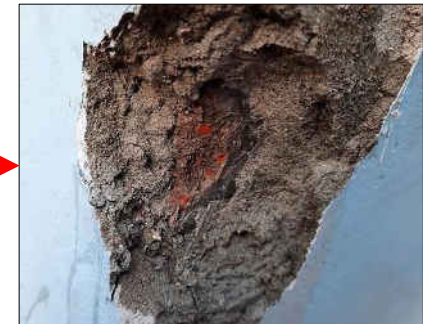
Rebar Scans

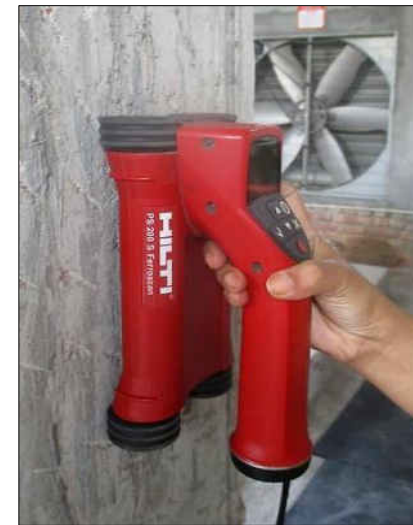
A bit of marked column was broken to determine aggregate type

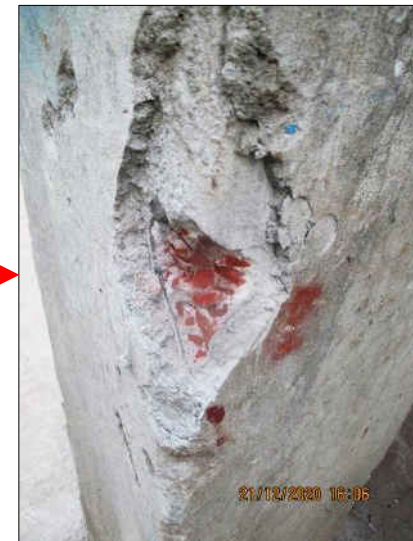
Rebar Scans
